Japan's World War II Balloon Bomb Attacks on North America

Robert C. Mikesh

SMITHSONIAN INSTITUTION PRESS

1973

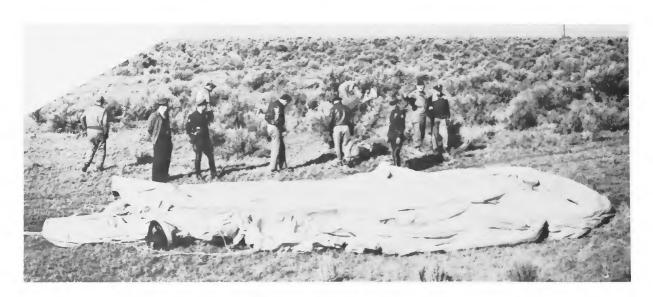
Figure 2. United States military and government officials inspect a Japanese balloon near Burns, Oregon, where it was discovered on 23 February 1945 (USAF 30776AC).

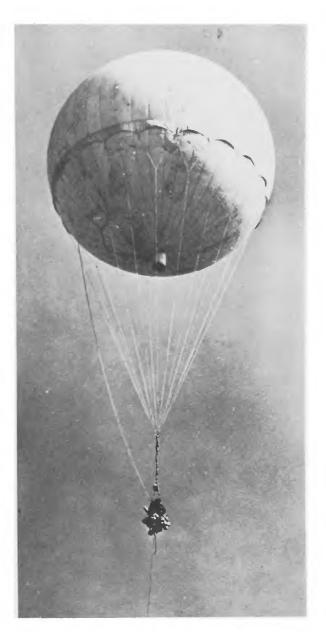
Figure 3. Japanese paper bombing balloon (A 37180C).

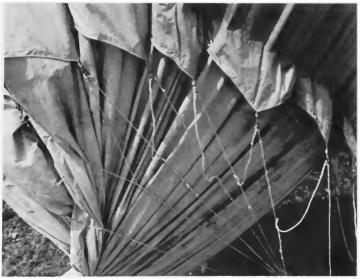
Figure 4. A faulty ballast-dropping mechanism caused this balloon to land, without dropping its bombs, near Tremonton, Utah, on 23 February 1945. Little damage was caused to the envelope.

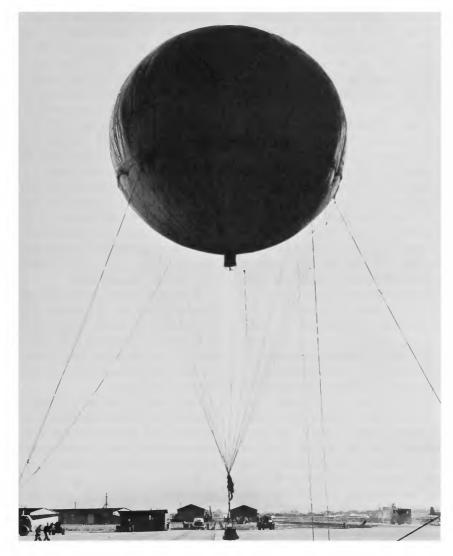
Figure 5. Americans were quick to inflate a recovered Japanese balloon for inspection of all components. This balloon was retrieved intact near Alturas, California, on 10 January 1945. (U.S. Army photograph, SC-226135)

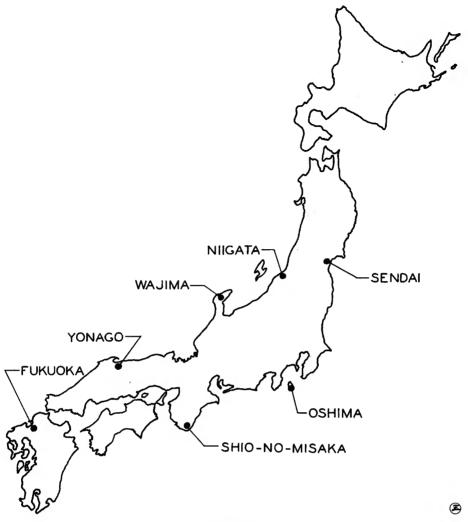
Figure 6. Radiosonde plotting-station locations in Japan used for upper wind study in 1945.

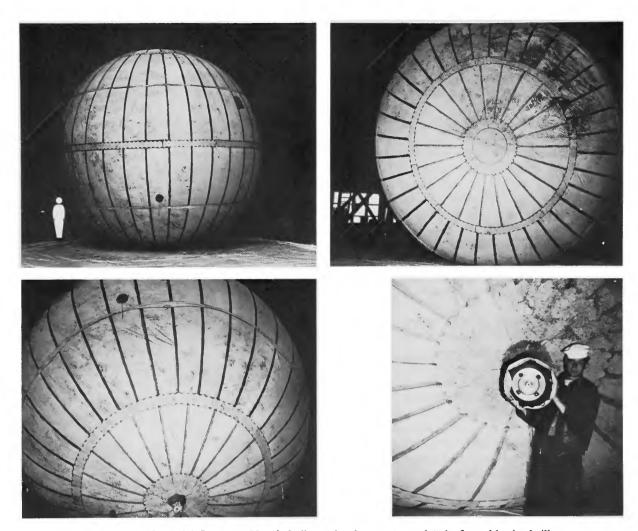
Figure 7. Imperial Japanese Navy's balloon development consisted of a rubberized-silk envelope. Due to the weight, its payload was much less than the paper balloon developed by the army. (U.S. Air Force photograph, 30770).

Instead of controlling altitude by the release of ballast and venting excess gas pressure, as was the case with the paper balloon, the navy's version was sealed after filling, being designed to keep its volume constant, yet strong enough to tolerate pressure changes with temperature and altitude. Flight altitude was relatively stable, making this one of the more favorable features of this balloon concept. Consistent flight altitude made for

better plotting of weather data and tracking the balloon flight path; however, readings of gas pressure became their highest by 3:00 P.M. daily during flight and many balloons failed at this point in time. A safety valve was then installed on subsequent balloons that would vent hydrogen at 50 millimeters Hg (by mercury barometer)⁵ which resolved the problem. This retained sufficient pressure, causing little effect upon buoyancy. A lightweight and simple ballast-dropping mechanism was also employed.

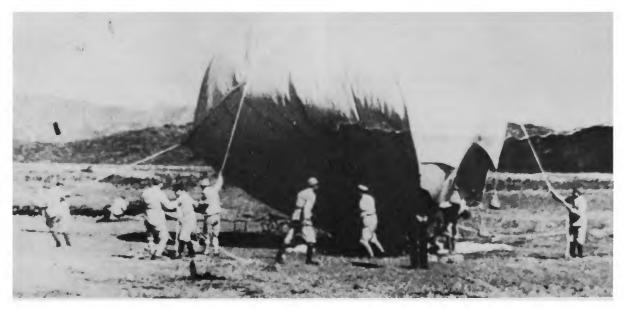
Figure 8. Japanese technicians struggle with an experimental balloon operation at the Sagami Arsenal in the spring of 1944.

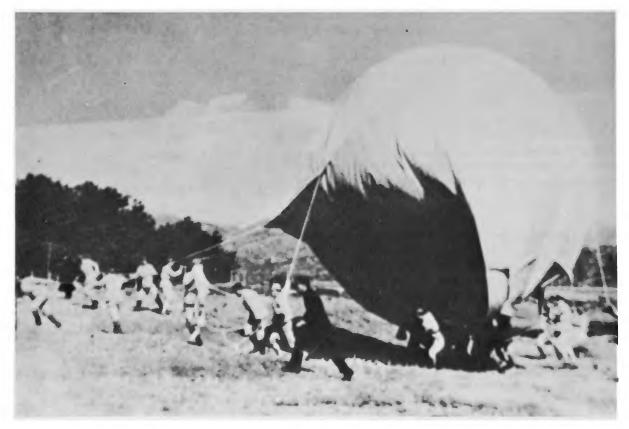
Figure 9. Surface wind was the greatest detriment while filling the balloons and releasing them for flight.

Filling the balloon with hydrogen was most difficult and dangerous on windy days. Desirable wind conditions for launching could be expected only three to five days a week. Even then, it could be done for only several hours at a time, usually just before the onshore breezes at sunrise. On occasion, some launches took place in the

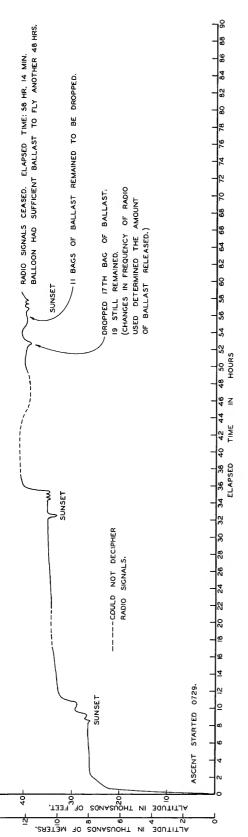
Figure 10. Japanese recording of paper-balloon test flight of 29 August 1944.

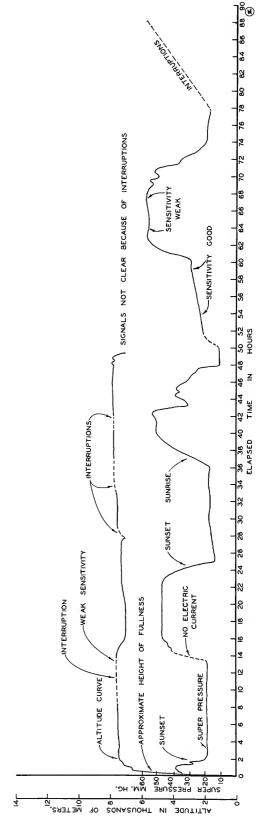
Figure 11. Rubberized-silk balloon flight recording conducted by Japanese technicians on 29 September 1944,

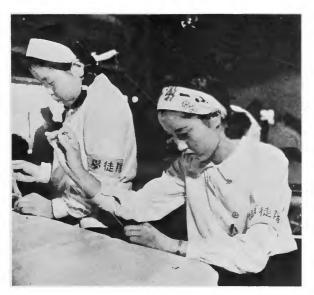
Figure 12. Great numbers of Japanese high-school girls were used in the delicate work of pasting and stitching the balloon envelope.

The raw, handmade, standard-weight paper made from the mulberry tree was fifteen grams per square meter. Strength was gained by laminating the three and four layers of paper alternately lengthwise and breadthwise. Next, the panels were softened by dipping them in a solution of soda ash, a water wash, and then a solution of glycerine. The glycerine wash was soon replaced with calcium chloride and other softeners since munitions powder had a higher priority for the glycerine than the balloon project. After the panels were dried, the edges were trimmed and panels were pasted together on a spindle form, the upper part first, then the lower part. Each balloon consisted of 600 separate pieces of paper, all having to be glued together with no allowance for gas leakage. After the relief-valve neck was installed in the lower hemisphere, both hemispheres were joined together by an encircling scalloped band which was glued on. This band formed the suspension skirt to which the shrouds were attached.

A large floor area was required for the shaping and final assembly room. All protrusions—not only on the floor but around the walls—were carefully wrapped with paper, to protect the balloon skin from damage. It was difficult to detect skin abrasions once the balloon was assembled. Girls that were making the balloons were instructed not to wear hairpins, to have closely trimmed fingernails, to wear socks even in the midsummer heat, and to use gloves despite the fact that their work required manual dexterity.

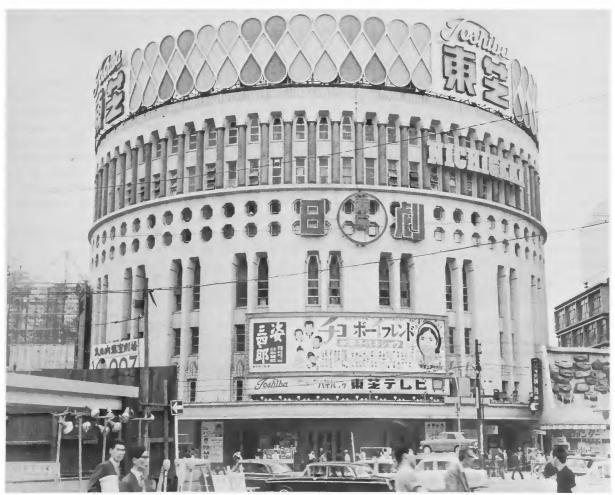
Figure 13. Large arenas and theaters were used for balloon production and inflation testing. One building was the Nichigeki Music Hall, a familiar modern-day landmark in downtown Tokyo.

To test the balloons for possible leaks, buildings large enough to house the inflated thirty-three-foot-diameter envelopes were required. Large theaters and sumo wrestling halls were ideal, but more were needed and had to be built for the testing which added considerably to the cost of the balloons. Such buildings as the Nichigeki

Music Hall and the Toho Theater in Tokyo, and Kokugi-Kan Wrestling Hall in the Tokyo borough of Asakusa were used.

For the test, the balloon was filled with air blown into it at a pressure of 120 meters of water column, after which it was sealed. After twenty-four hours, it was checked for leakage. Those that were satisfactory were then coated with a protective lacquer.

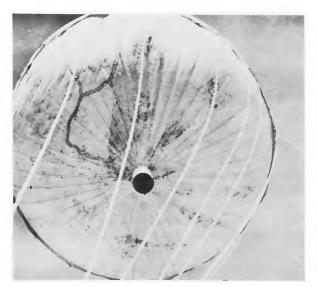
Figure 14. A skyward view of an inflated balloon held captive by its shroud lines. The gas relief valve is shown at the base of the envelope. (A 37180F)

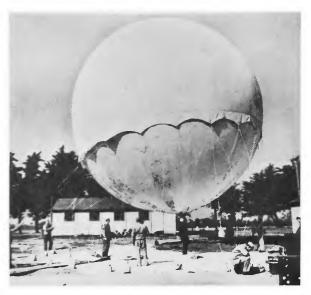
Figure 15. The Japanese paper balloons were 32 feet in diameter and, when fully inflated, held about 19,000 cubic feet of hydrogen. (A 37180F)

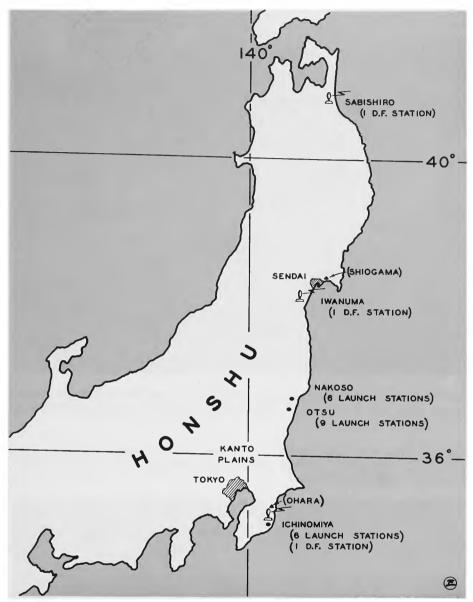
Figure 16. Balloon launching sites and flight-following stations.

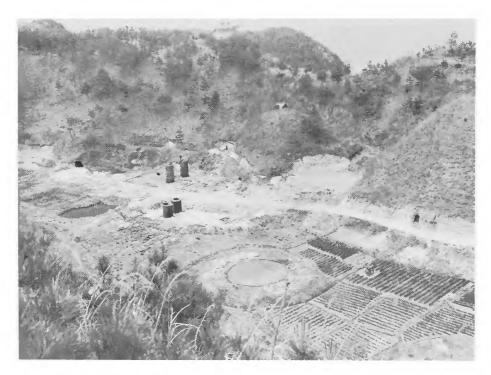
Figure 17. Balloon launching complex at Otsu after the war. Note the shelter caves in the side of the hills and the sea in the background. (U.S. Army photograph, SC 284816)

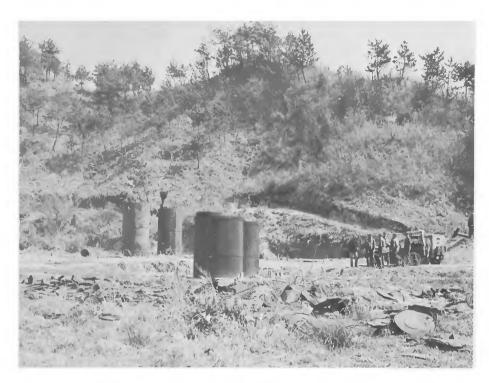
Figure 19. The seclusion of the hills aided as a windbreak when filling the balloons, as well as security from detection. (U.S. Army photograph, SC 283809-S)

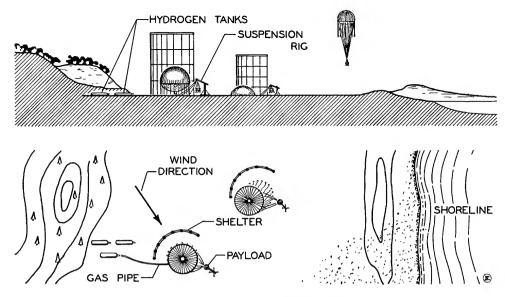
Figure 21. Profile and plan-view of balloon launching facility at Ichinomiya.

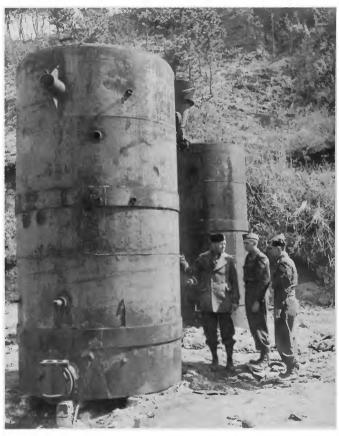
Figure 23. Rusty tanks for the hydrogen generating plant is all that remains of this former balloon launch site. Only Otsu had its own gas facilities. (U.S. Army photograph, SC 284185)

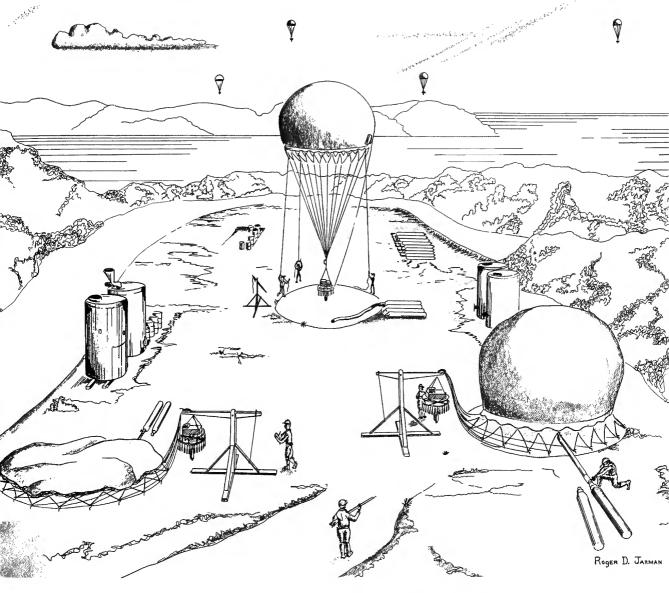
Figure 24. General view of one launch site with three pads in operation.

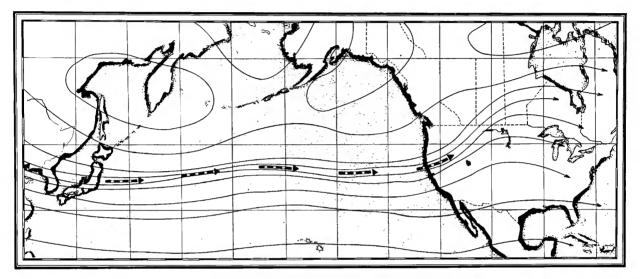
Figure 25. A typical balloon flight profile is shown above; below, a typical jet stream in winter months.

of greatest velocity, the days had to be clear and with relatively no surface wind. In ascending through rain, snow, and even some clouds, the balloon accumulated moisture which froze—adding much weight—and prevented it from reaching operating altitude. It was vitally important that the balloon ascend into the fast-moving jet stream so that the programmed release of the ballast and dropping of the bombs would occur over the North American continent. Failure to reach the jet stream meant that the balloon would self-destruct before spanning the Pacific.

The best time to launch was just after the passing of a high-pressure front. Launching conditions were unsuitable if a high-pressure front was approaching, or a low-pressure front had just passed.

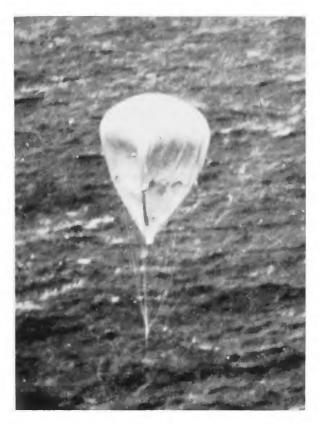
Figure 26. Partially inflated balloon, with its bomb load, in flight over the Pacific Ocean drifting toward the American continent. (U.S. Army photograph, SC 226132)

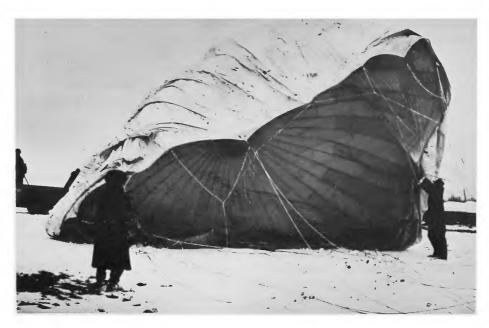
Figure 27. Wind catches a recovered balloon like a parachute. Note the arrangement of the gores on the lower surface with the relief valve in place. Photo taken on 23 February 1945. (29907 AC)

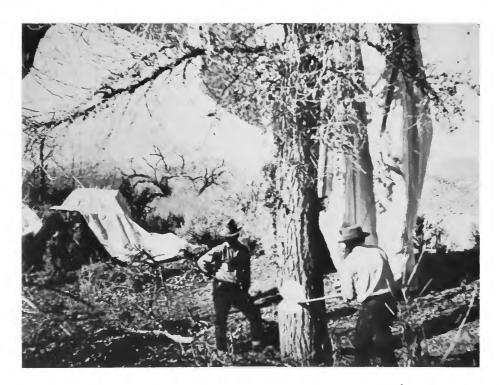
Figure 28. Elaborate measures were sometimes taken in the recovery of these balloons for closer inspection. Here, Indians chop down a treed balloon which landed harmlessly on 29 March 1945 at Pyramid Lake, Nevada. (29906 AC)

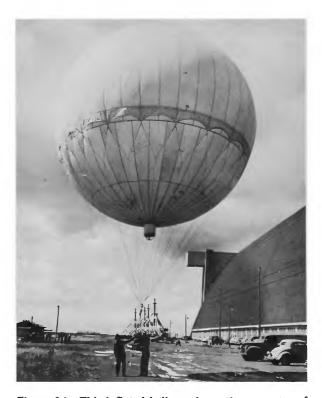
Figure 34. This inflated balloon shows the geometry of the many paper gores which make up the gas-proof envelope. Nineteen shroud lines attached to the cloth skirt carry the gondola. (U.S. Navy photograph, 80-G-326353, in the National Archives)

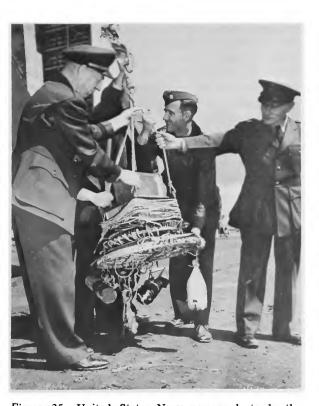
Figure 35. United States Navy personnel steady the ballast-dropping mechanism and bomb-carrying device. The main bomb is suspended in the center, while a ballast sandbag hangs at the right. (U.S. Navy photograph, 80-G-326354, in the National Archives)

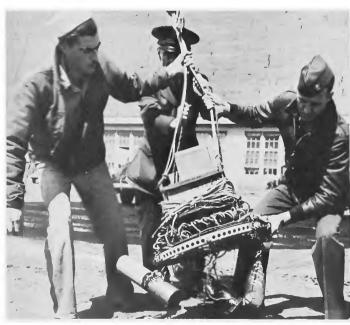
Figure 36. On the left periphery of the release ring is a 5 kg thermite incendiary bomb sometimes used as ballast in the last release stations prior to the dropping of the main bomb. (U.S. Navy photograph, 80-G-326355, in the National Archives)

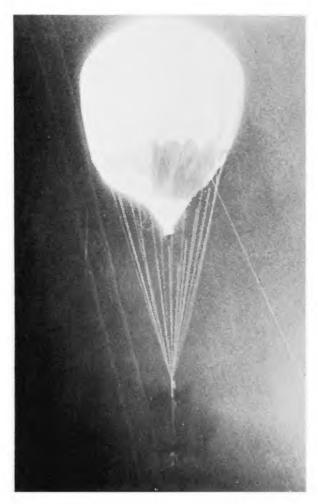
Figure 38. Fighter-aircraft gun-camera film catches a balloon in flight. At the lower altitudes, the gas contracts which cavitates the lower portion of the sphere giving the impression of a parachute. (30771 AC)

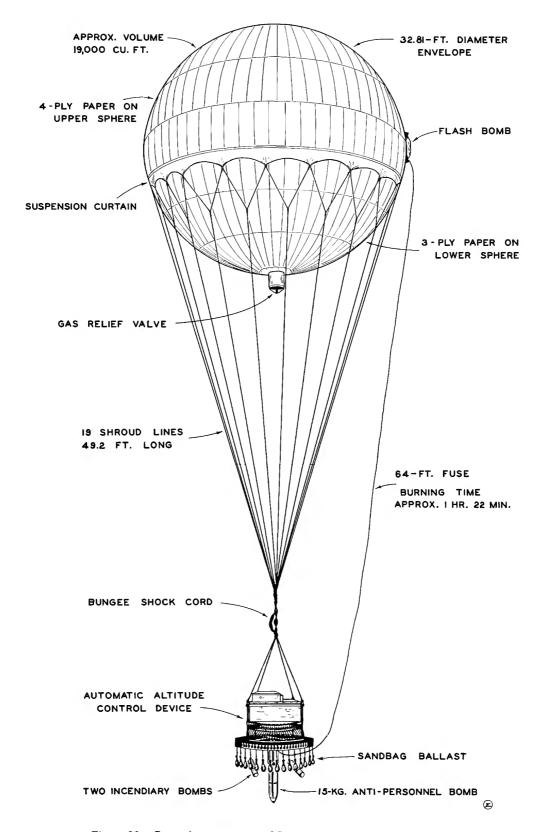
Figure 39. General arrangement of Japanese paper bombing balloon.

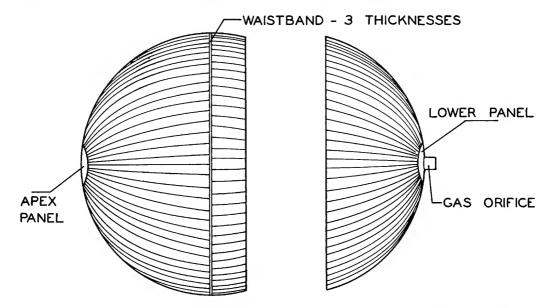
- 4. UPPER HEMISPHERE ASSEMBLY 5. LOWER HEMISPHERE ASSEMBLY

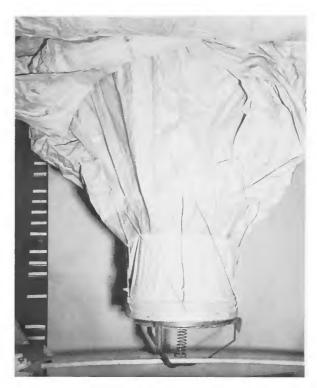
Figure 41. Gas relief valve glued in position at neck of envelope. This balloon was recovered near Holy Cross, Alberta, Canada, on 21 January 1945. (U.S. Army photograph, SC 237084)

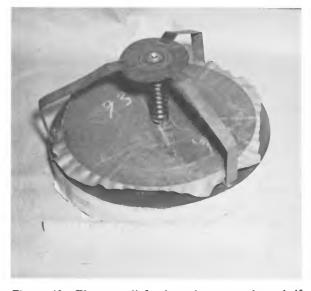
Figure 42. The gas relief valve, nineteen and one-half inches in diameter, was spring-loaded against a one-ounce-per-square-inch gas pressure. This valve, marked with a chalk number "93," was recovered at Marshall, Alaska, 23 December 1944. U.S. Army photograph, SC 237090)

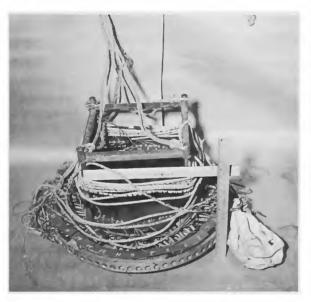
Figure 46. Though damaged by its use, this control frame was recovered near Marshall, Alaska, 23 December 1944. Note fuses circling frame. (U.S. Army photograph, SC 237091)

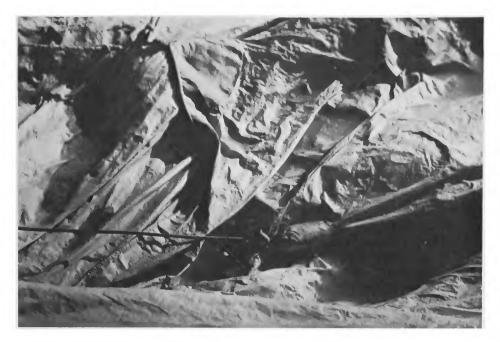
Figure 48. Close-up of the ignition charge attached to the side of the envelope and fuse leading to it. At the top left is a shroud line attached to the catenary band. (30781 AC)

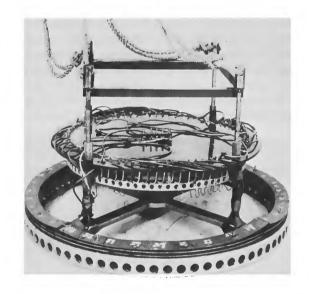
Figure 49. Ballast release and control frame. (A72-868)

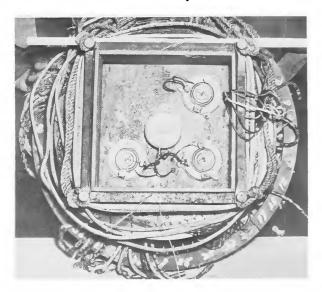
Figure 50. Box cover containing aneroids is removed for viewing into the control device. (U.S. Army photograph, SC 226133)

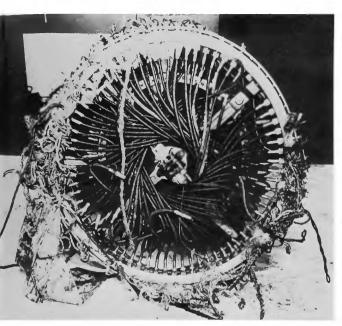
Figure 52. Bottom view of ballast-releasing control device. The ballast sandbags were mounted on the outer ring, while the main bomb was supported by the central shackle. (SC 226138)

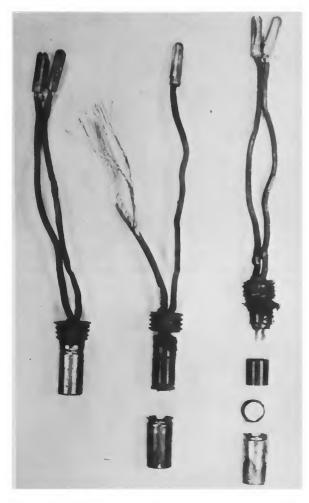
Figure 58. Igniter squibs. (A72-874)

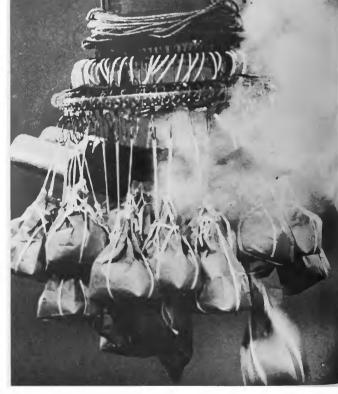
Figure 67. The bomb load and full ballast attached to a Japanese balloon gondola. Exploding blowout plug releases a sandbag shown in this movie still. The cycles continue, finally releasing the two incendiaries at left and the 33-pound, anti-personnel bomb which hangs nose down in the center. (29910 AC)

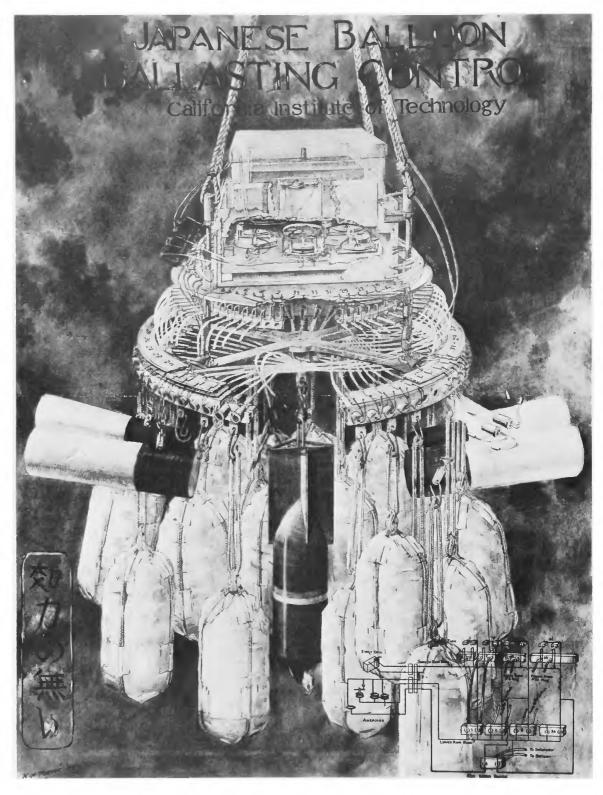
Figure 69. Minutely detailed, exploded-view drawing prepared in 1945 shows the workings of the ballast and ordnance-dropping mechanism. (A 37180D)

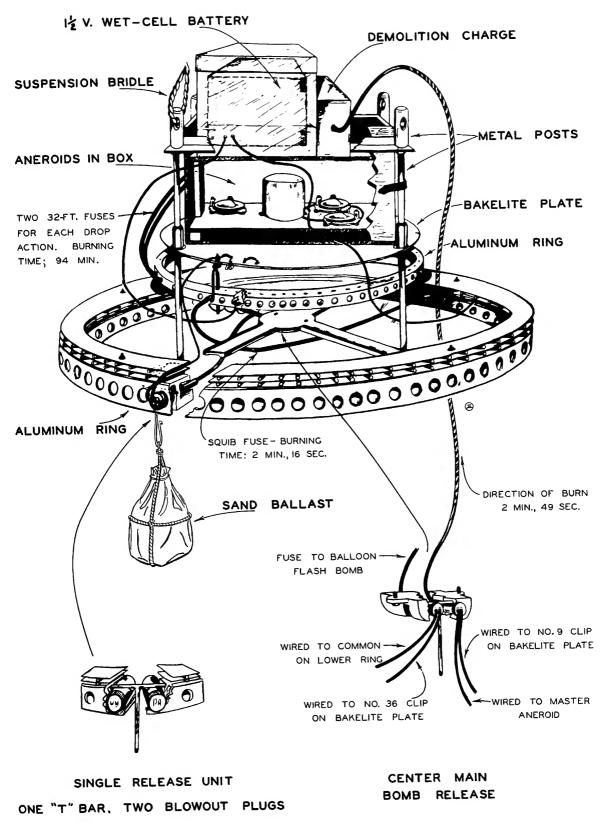
Figure 70. Automatic altitude-control device.

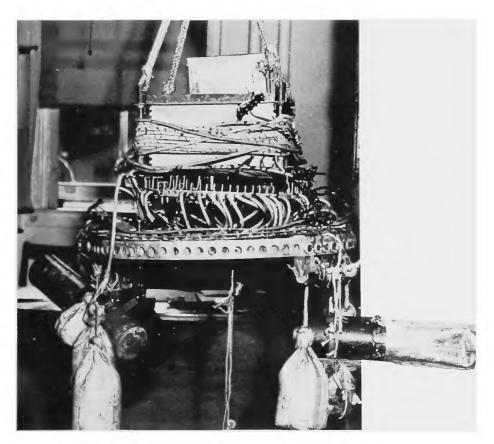
Figure 71. Though complicated in appearance, the operating principle of the altitude-control system was quite simple. Time burning fuses encircle the aneroid-containing box which supports the battery box above. (U.S. Army photograph, SC 226136)

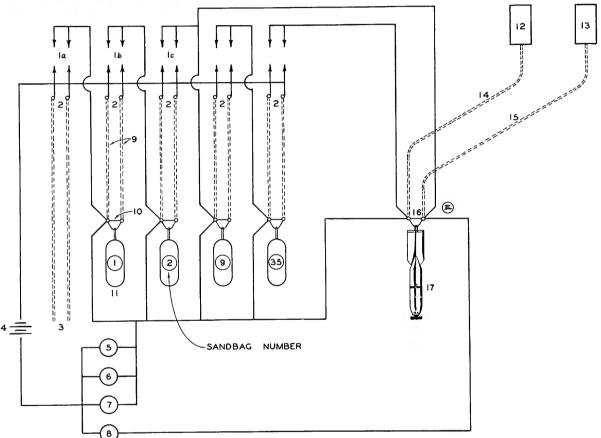
Figure 73. Schematic diagram of altitude-control apparatus for a paper bombing balloon.

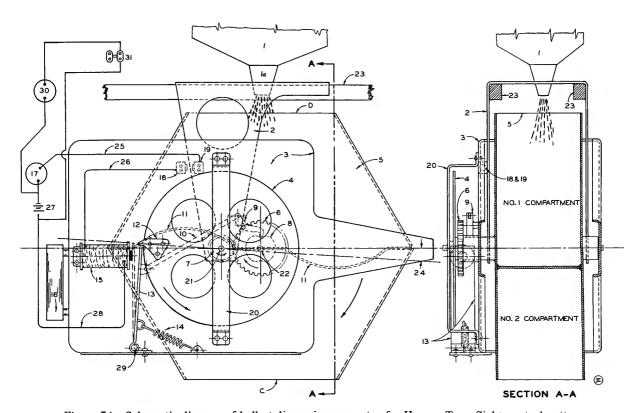
Figure 74. Schematic diagram of ballast-dispensing apparatus for Hopper-Type flight-control unit.

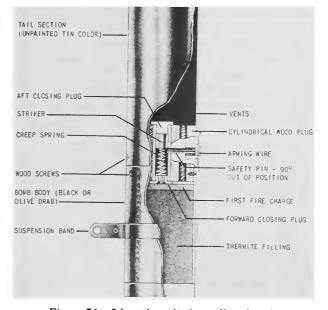
Figure 76. 5-kg., thermite incendiary bomb.

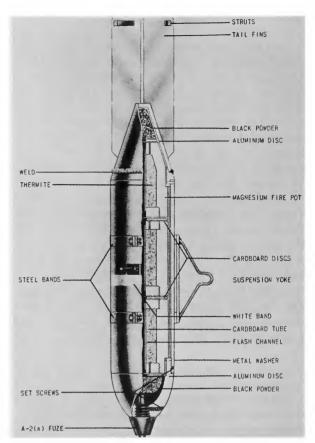
Figure 78. Type 97, 12-kg., thermite incendiary bomb.

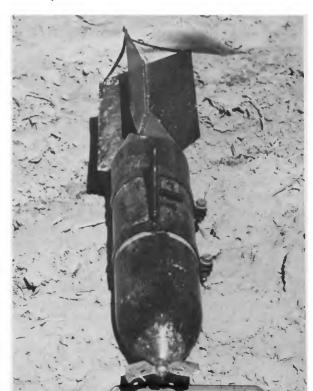
Figure 79. This 33-pound anti-personnel bomb was usually the main weapon carried on the central shackle of the release mechanism. (U.S. Army photograph, SC 226137)

Depending on the choice, from two to six pieces of ordnance could be carried on each balloon. (Far less than the proposed number of balloons were released; however, the ordnance sent aloft was in the above proportions.) According to one Japanese source, the balloon load varied from a minimum of about twenty-

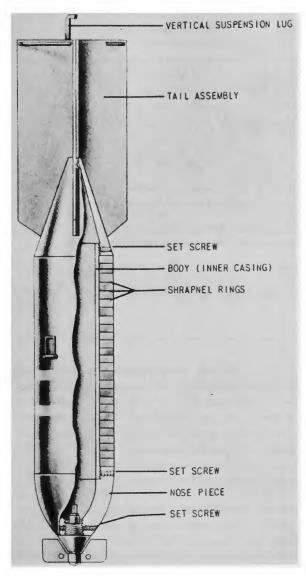
Figure 80. Type 92, 15-kg., high-explosive bomb.

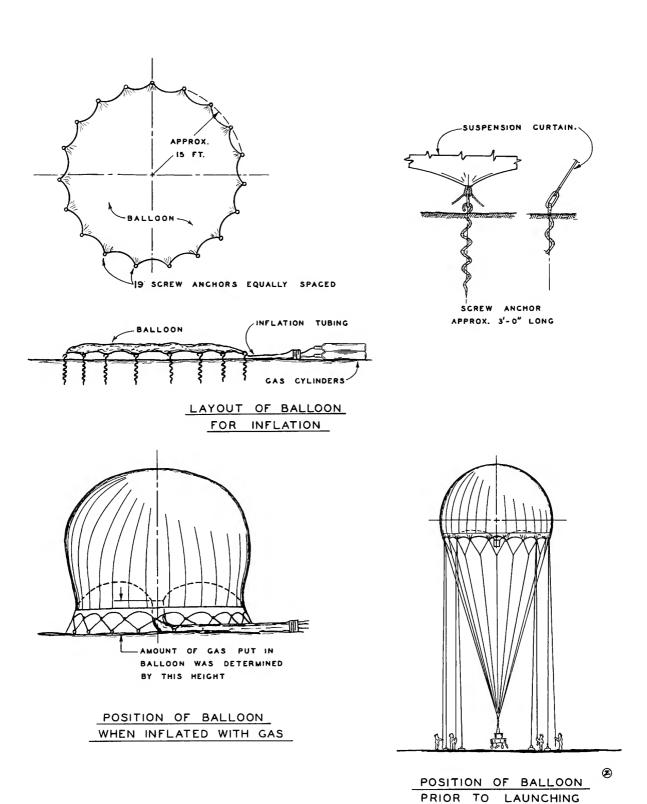
Figure 81. Layout for anchoring and inflating bombing balloons for launching.

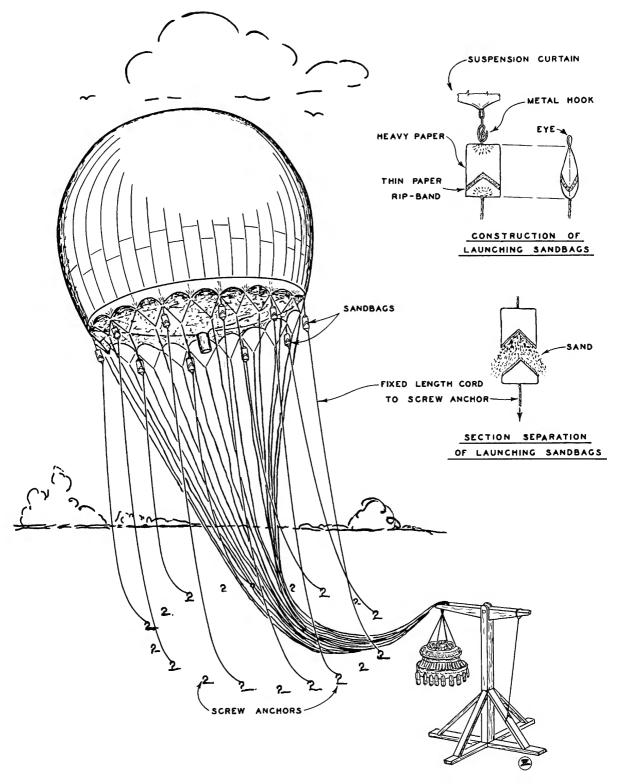
Figure 82. Method used for launching bombing balloons in winds above two and one-half miles per hour.

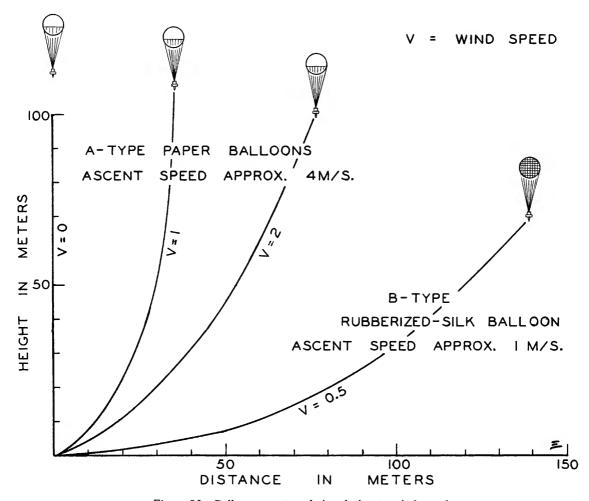
Figure 83. Balloon ascent angle in relation to wind speed.
